National Transportation Safety Board Aviation Accident Preliminary Report

Location:	Hermantown, MN	Accident Number:	ERA23FA001
Date & Time:	October 1, 2022, 23:17 Local	Registration:	N262TA
Aircraft:	Cessna 172S	Injuries:	3 Fatal
Flight Conducted Under:	Part 91: General aviation - Personal

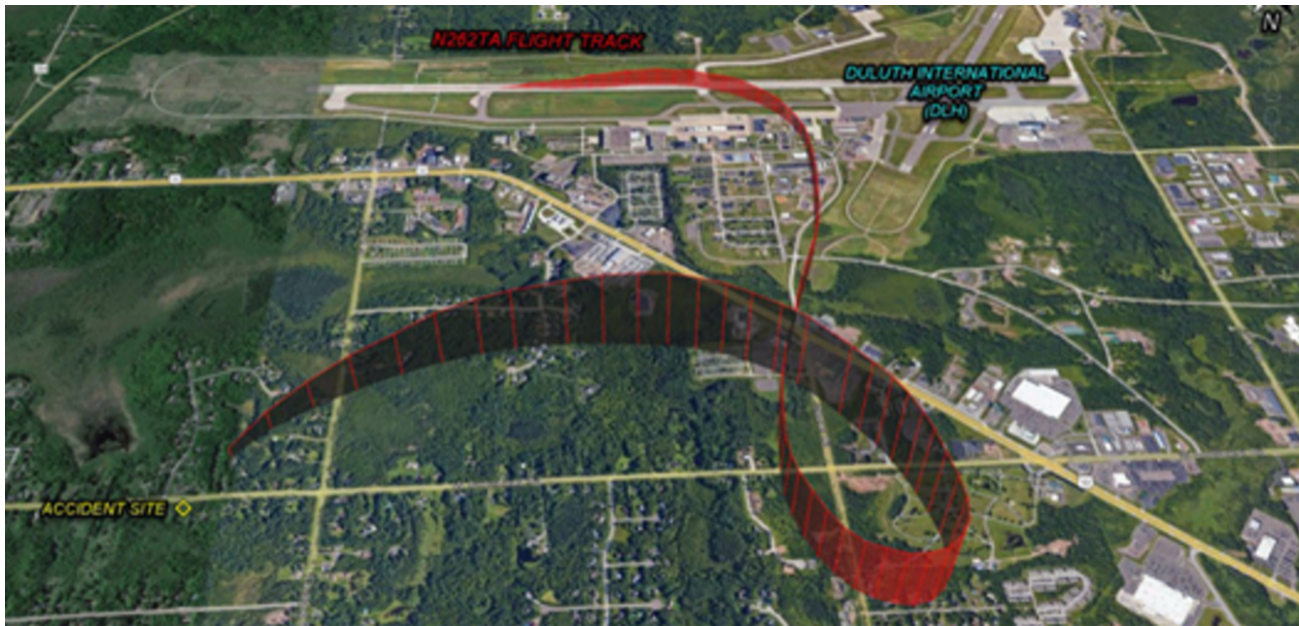
Preliminary Automatic Dependent Surveillance–Broadcast (ADS–B) data indicated the flight departed DLH runway 09 at 2312, then turned on a southerly track while climbing to about 1,750 ft mean sea level (msl) about 1 mile south of the departure runway. The airplane entered a tight teardrop turn to the left while climbing through 2,000 ft msl, then continued the turn 360° until it was on a track of about 270° at 2,800 ft msl, then began a descent (see figure 1.)

Figure 1. ADS-B data depicting accident flight track in profile view.
